HERITAGE COUNCIL OF WESTERN AUSTRALIA

CONSERVATION PLAN DONNELLY RIVER MILL

MARCH 1994

G B HILL & PARTNERS PTY LTD
62 COLIN STREET
WEST PERTH WA 6005

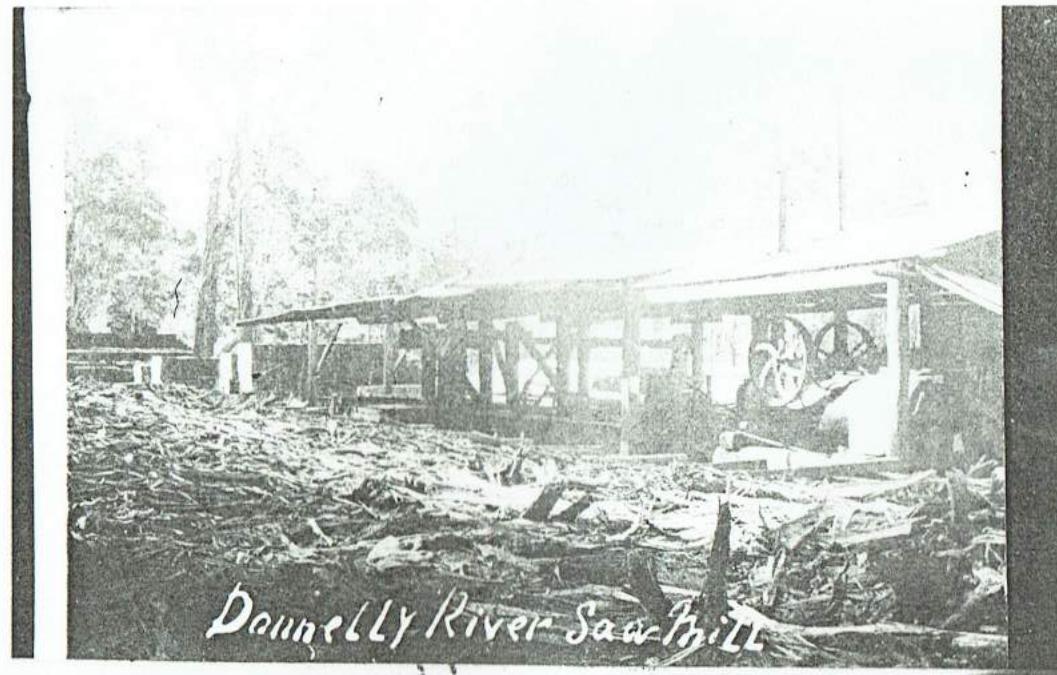
A small timber mill known as Wheatley's Mill had operated in the area during the period of the First World War. (Photo 1)

1. Photograph Of The Original Wheatley's Mill At The Donnelly River Mill Site.

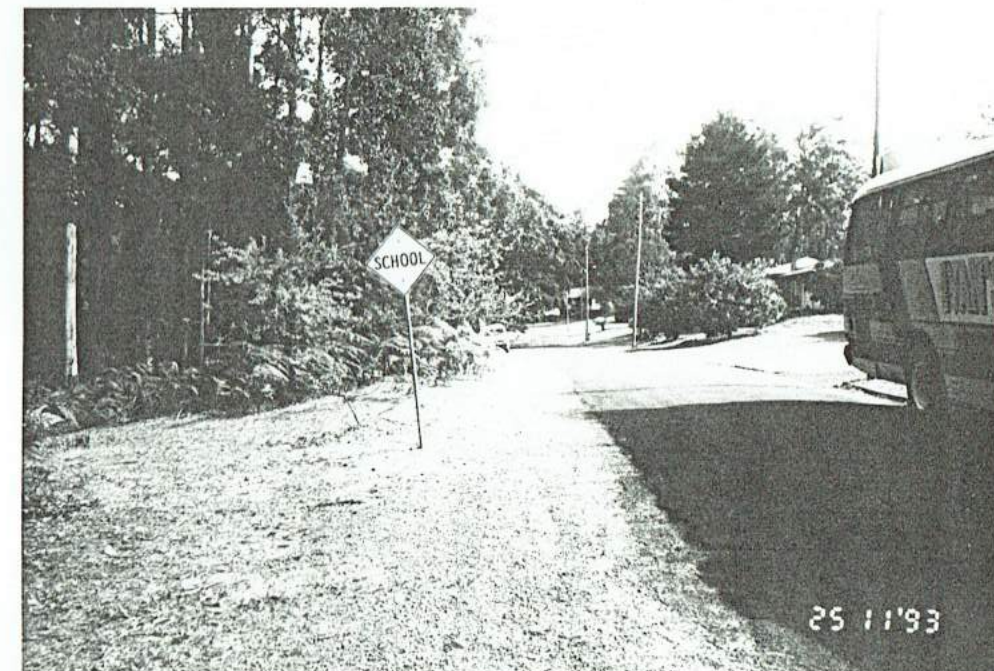
This study relates particularly to the Donnelly River Mill, however a feature is not only the high proportion of the mill structures and equipment still remaining but also the extent of the remaining mill office, workshop, housing, school, boarding house, recreation areas and club. (Site Plan Appendix 2, Photo 2).

2. Photograph Of Existing Mill Town Housing, School etc.

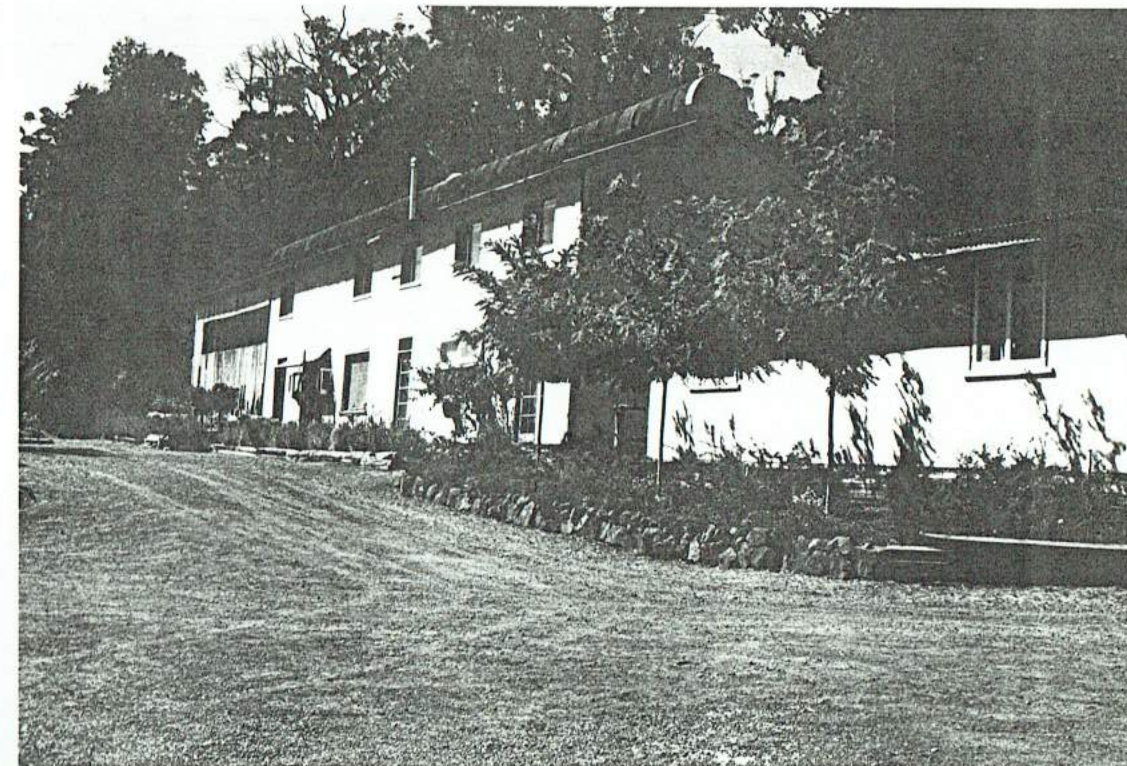
The locomotives shed is also outside the perimeter fence and this is currently being modified to provide further short stay tourist accommodation. (Photo 4)

4. Converted Locomotive Shed. *February 1994*

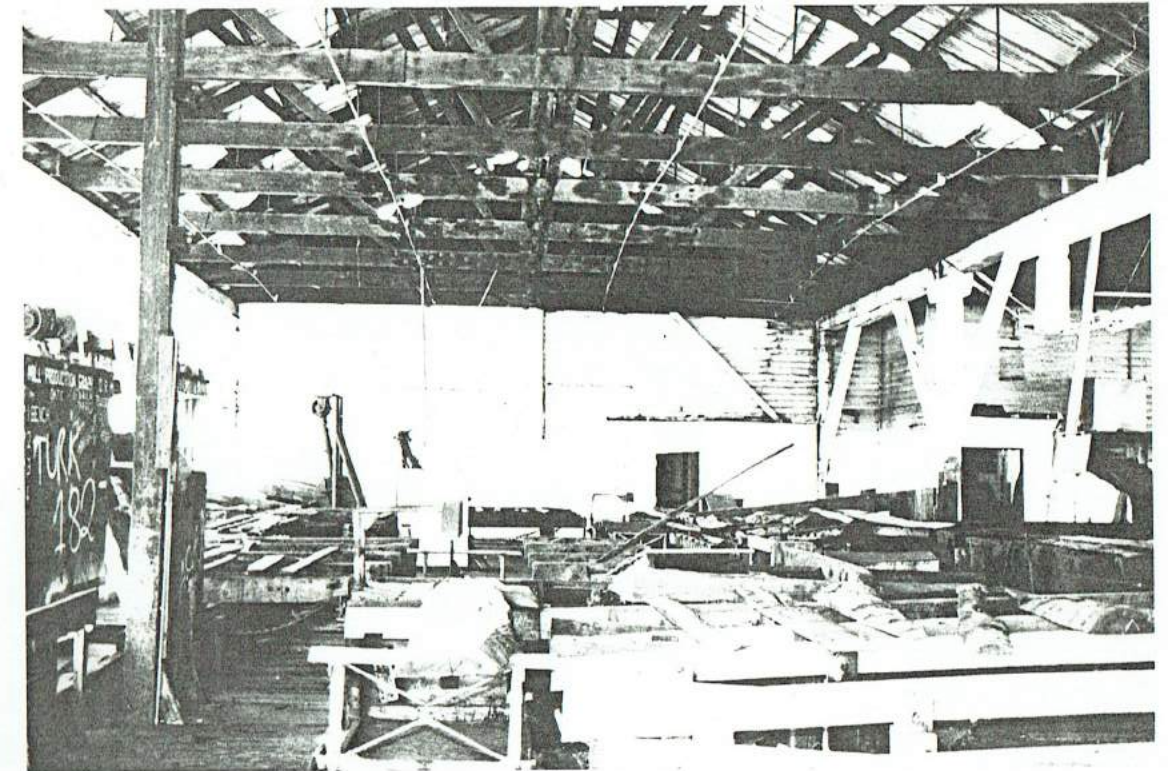
6. ^{Existing} Section Of Mill Benches. 1994

The basic structure of the mill is the mill floor which supports the operating equipment above the floor and also the drive shafts, pulleys and belts under the floor. This is different from the usual practice in workshops with drive shafts and pulleys in the roof with belt drives coming down onto the work benches, however below the floor drive equipment was the practise in timber mills. (Photo 6)

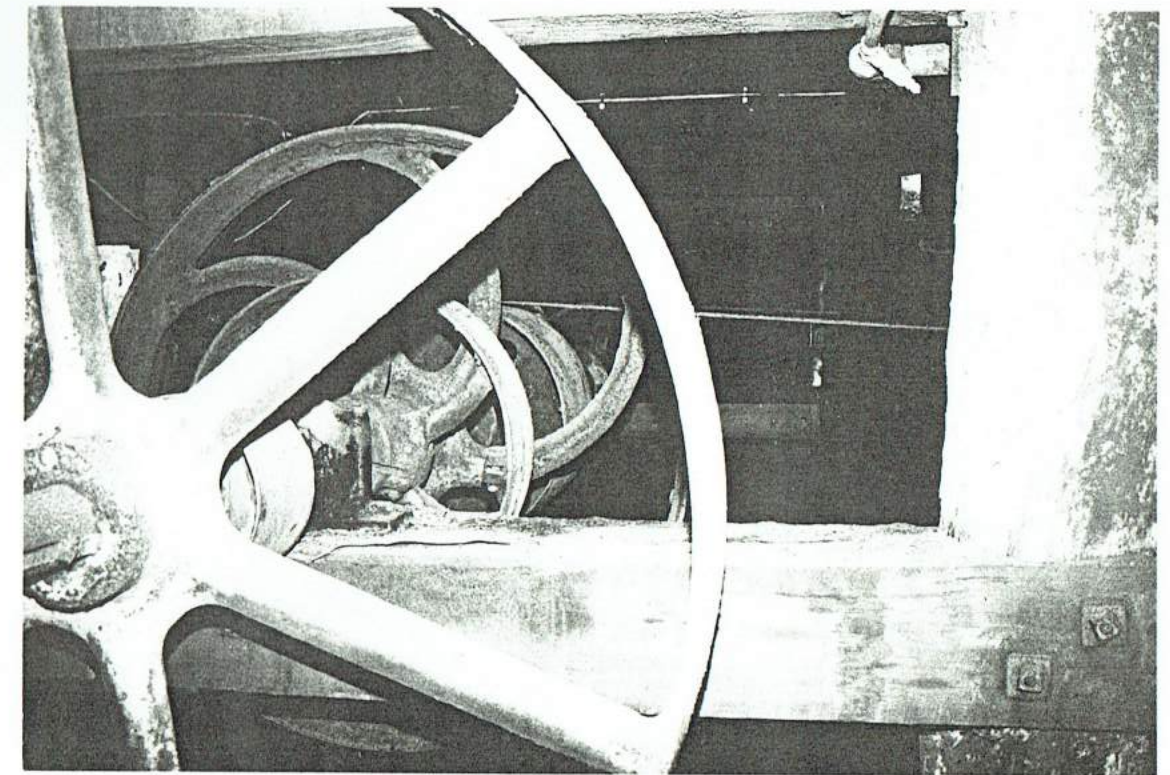
7. Drive Shafts Under The Mill Floor Providing Direct Power From The Robey Steam Engine To The Mill Equipment. 1994

The purpose of all drive equipment being below floor level is to achieve an open path for the movement of timber through the mill and also improve safety. (Photo 7)

An inspection of the operating floor support structure indicated this to be in reasonable condition, although sections of the floor boards are in need of maintenance. The entire floor support structure consists of heavy bush timber braced with sawn mill timber. Further details are included in Section 5 of this report.

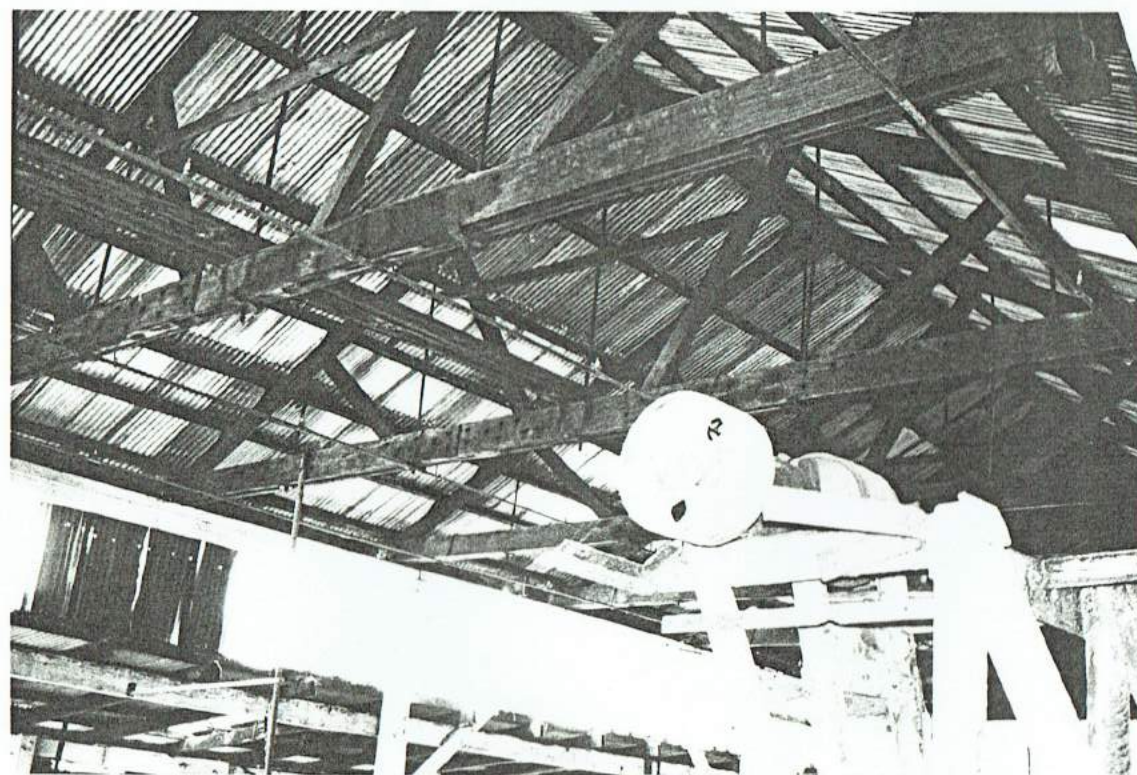
8. Mill Roof Timber Trusses. February 1994

The support structure is all of timber construction with the support columns consisting of round bush timbers with the roof timbers and beams constructed from sawn timber. The roof trusses are all timber construction. (Photo 8)

The columns and roof timbers are structurally sound reflecting the original robust design. There is evidence of decay in some sections of the building which need to be rectified. Details are outlined in Section 5.

The timber roof support trusses are in reasonable condition together with the support columns and timber flooring. (Photo 8)

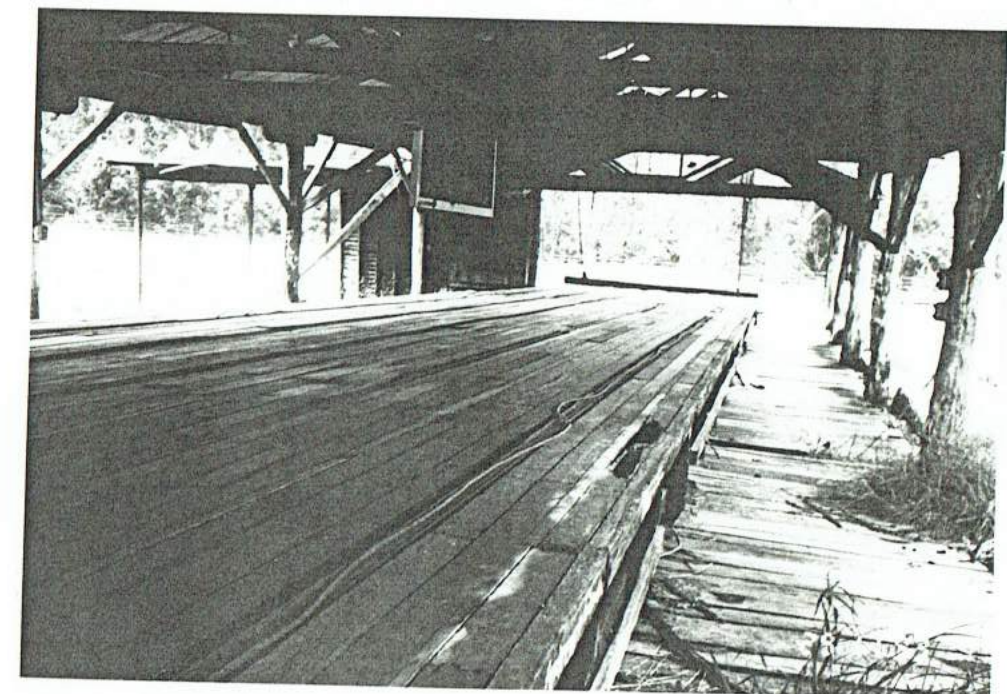
9. Existing Timber Sorting Table And Structures. 1994

Again this is a timber structure supporting the bench cables and the roof being sheeted in corrugated iron. Details are included in Section 5.

These structures are in reasonable condition although also in need of maintenance. Refer Technical Report Section 5.

Sections of the corrugated iron roofing are in need of repair.

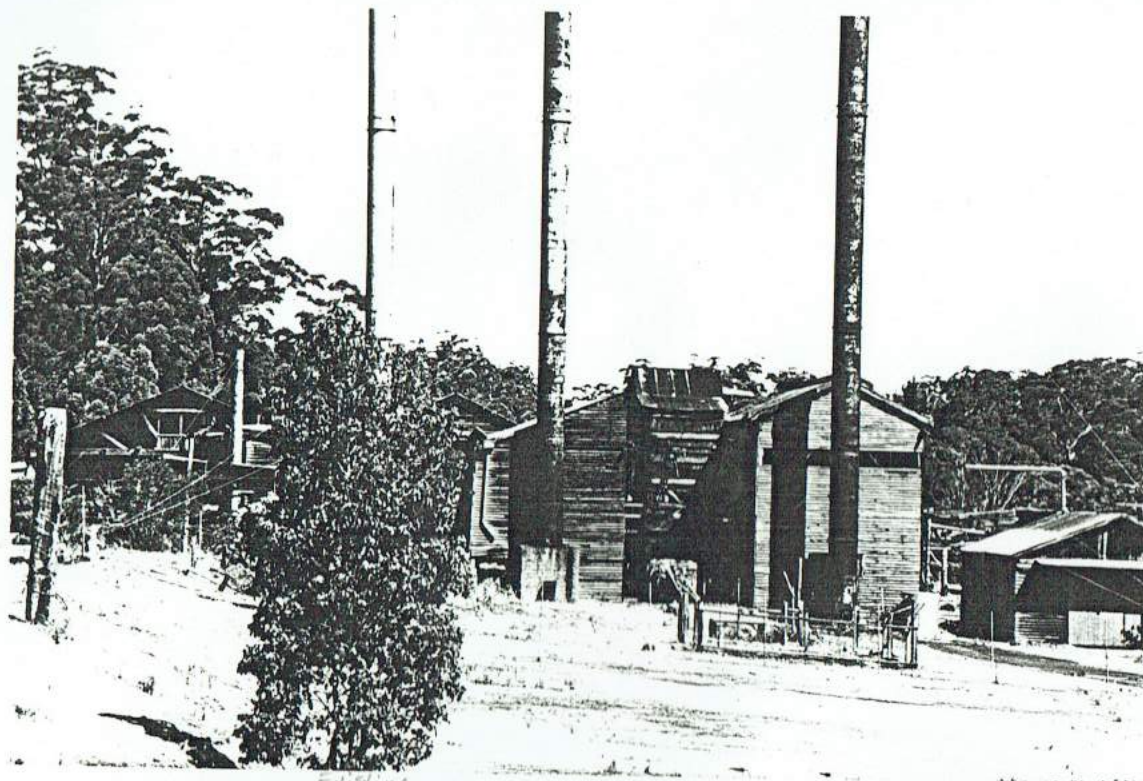
10. Photograph Of The Three Babcock And Wilcox Boiler Chimney Stacks. *EXISTING 1994*

These stacks are 20 metres in height of steel construction with anchored guy ropes providing for stability.

The stacks are in reasonable condition and all still supported by guide ropes. A technical report for these stacks is included in Section 5.3.1.14

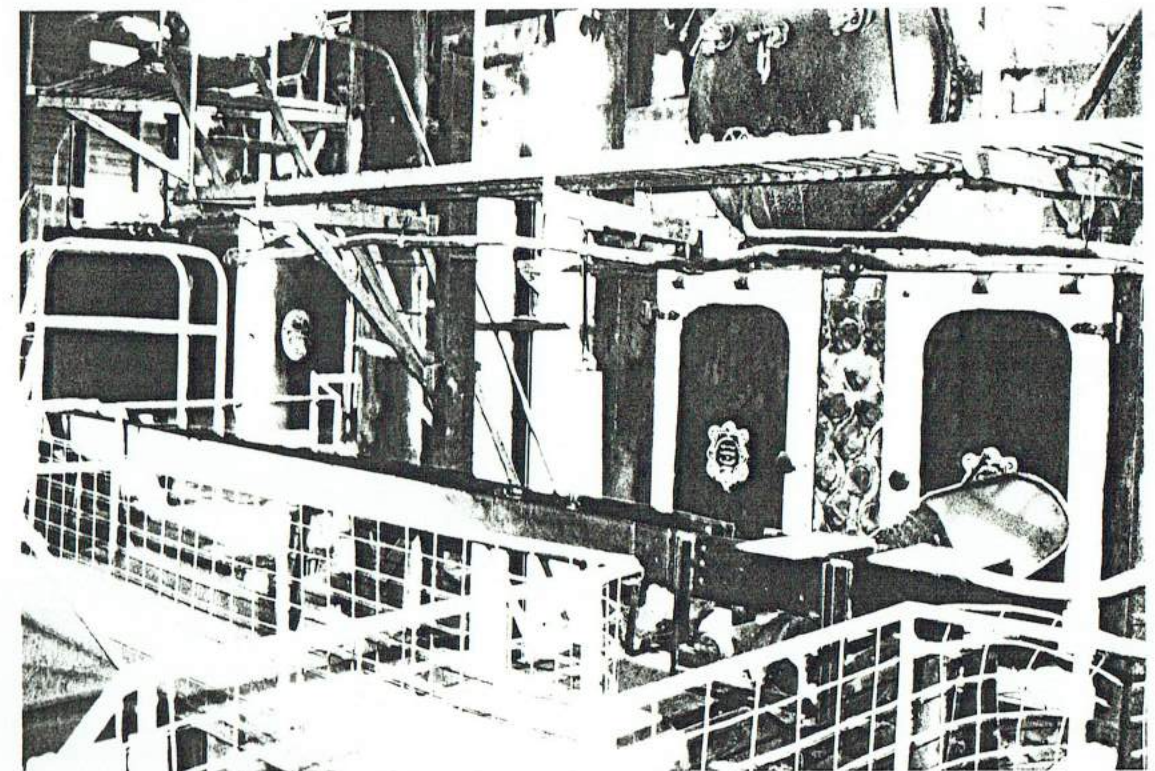
11. Photograph Of The Babcock And Wilcox Boilers. *EXISTING 1994*

The Babcock and Wilcox boilers generating steam for the engines are under a roof area at the eastern end of the mill and protected from the weather. (Photo 11)

The original construction of these boilers was of a high standard the brick housing and support structure being in good condition.

The boiler stairs and walkways at various levels are all of steel construction in reasonable condition.

The boilers, walkways and steam pipe distribution system are nearly all complete, although as to be expected there is some evidence of corrosion.

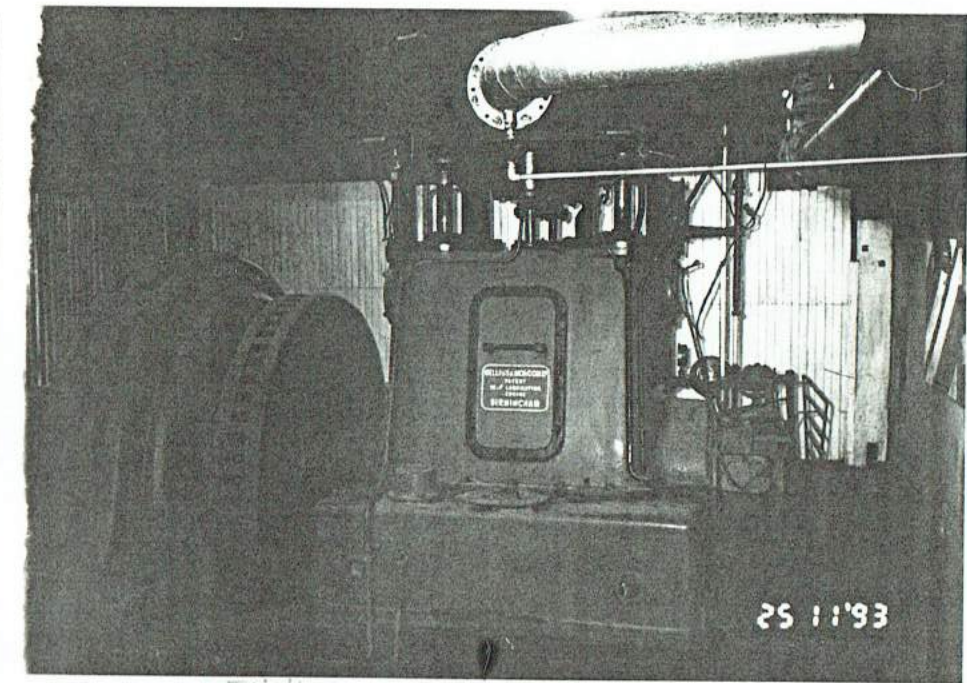
13. Photograph Of The Bellis And Morcom Steam Engine. 1993

One power generating steam engine the Bellis and Morcom remains in position in good condition. (Photo 13)

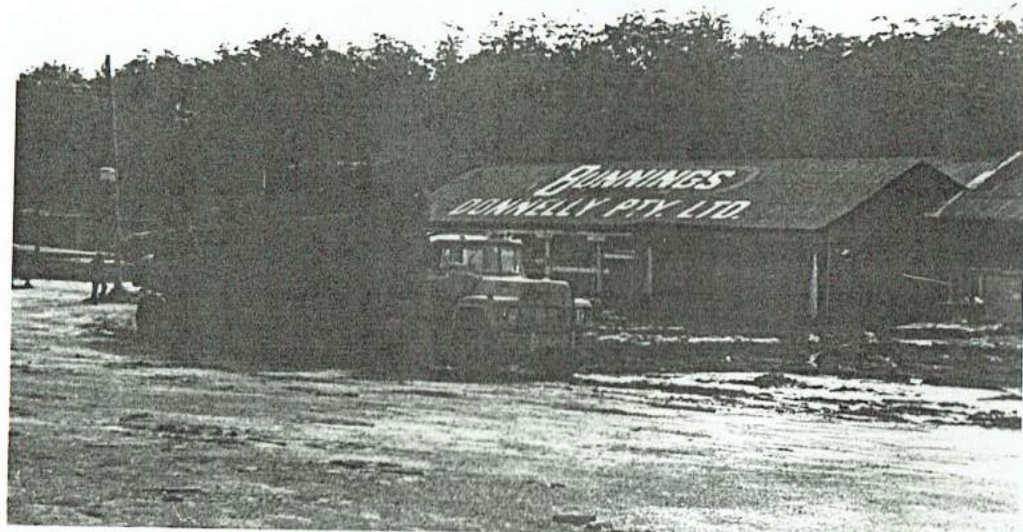
Logs carried from the bush were snigged from the log trucks into the storage stacks by means of a steel cable operated from winch A. This was carried out by the hookman, and as the logs were unloaded the logs were measured by the measurer for length, girth, brands of fallers and haulers recorded in the mill book. This information being required for the calculation of royalties, and the payment of the bush workers who worked on piece rates. The logs rolled down the steep skids from the log truck shaking the ground and coming to rest with a "thud" against the chocked log at the front of the landing.

18. Logs Being Delivered To The Mill. 1978

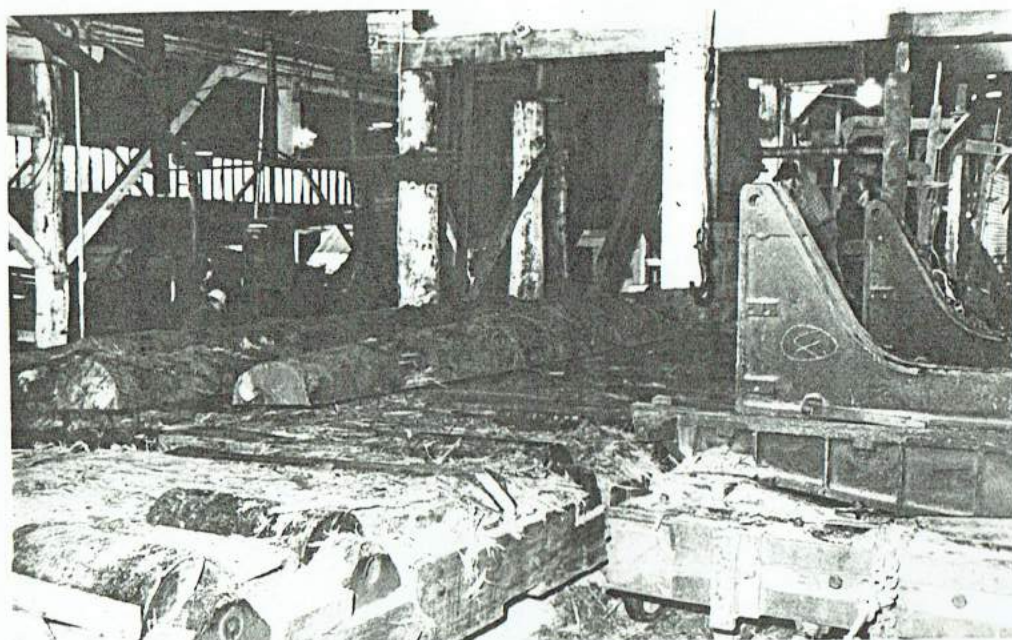
22. Flitches On Skids For Delivery To The No. 1 Saw Bench. *OPERATING MILL 1978*

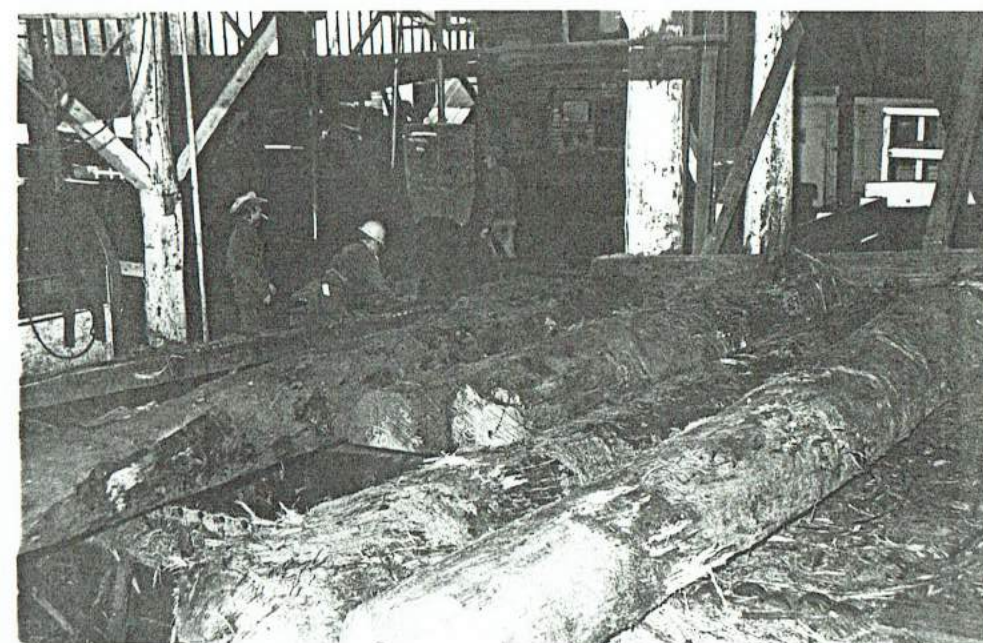
The flitches were positioned on a rail mounted trolley and assisted by the power rollers on the bench for further sawing to produce the larger timber sizes. To achieve this the flitches were passed through the No. 1 saw bench several times. This work was the responsibility of the benchman who was also responsible for positioning the flitch for easy handling. At the side of the bench was the leverman whose job was to drive the flitch over the bench with the aid of the friction rollers at each end of the bench. He also placed the pin in the correct hole to cut the required timber size. This size was indicated by the benchman using a code of signals as the mill noise made speech impossible.

OPERATING
23. ^ No. 1 Saw Bench. *1978*

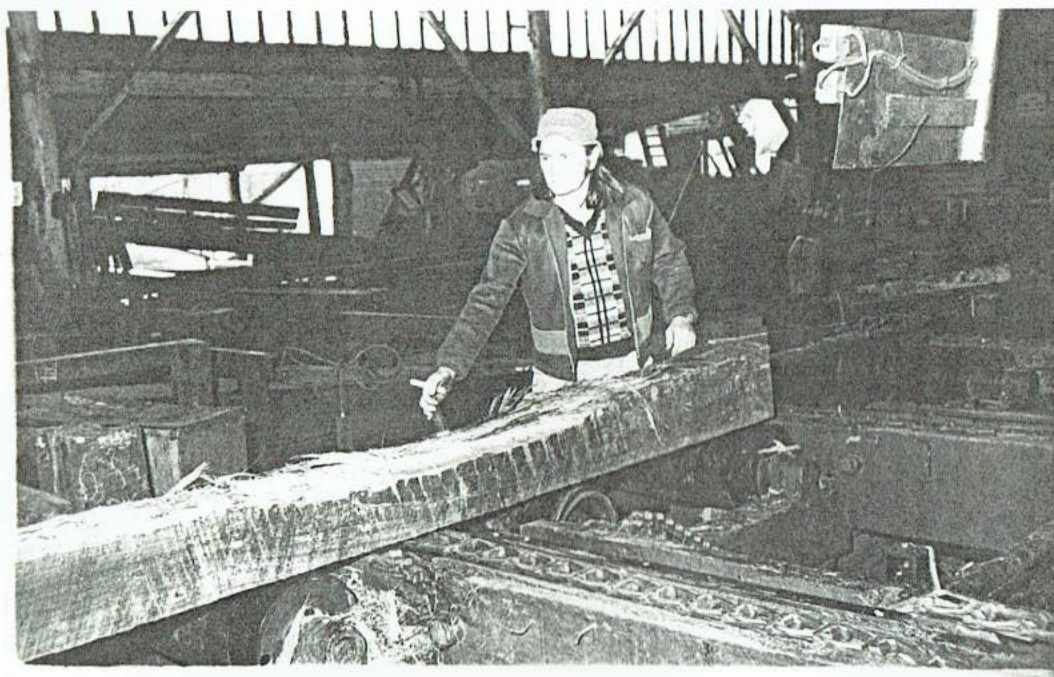
The sawn timber from the No. 1 bench passed onto the bench outlet skids which were equipped with powered rollers to move the timber onto the No. 1 saw bench powered rollers for movement of the larger sized sawn timber sections to the No. 1 docking saw to cut the timber to the required length.

24. Partly Sawn Timber Moving Through The Mill. *OPERATING MILL 1978*

Timber from the No. 1 saw bench was unloaded from the rail mounted trolley onto powered chains, which moved the timber sideways to the north onto rollers for either movement to the No. 1 docker and to the storage yard or No. 2 saw bench or further east for further sideways movement to the north for loading onto the rail trolley for entry to No. 3 saw bench (Refer plan Appendix 4). The power chains and rollers are shown on Photo 50 and Photo 24.

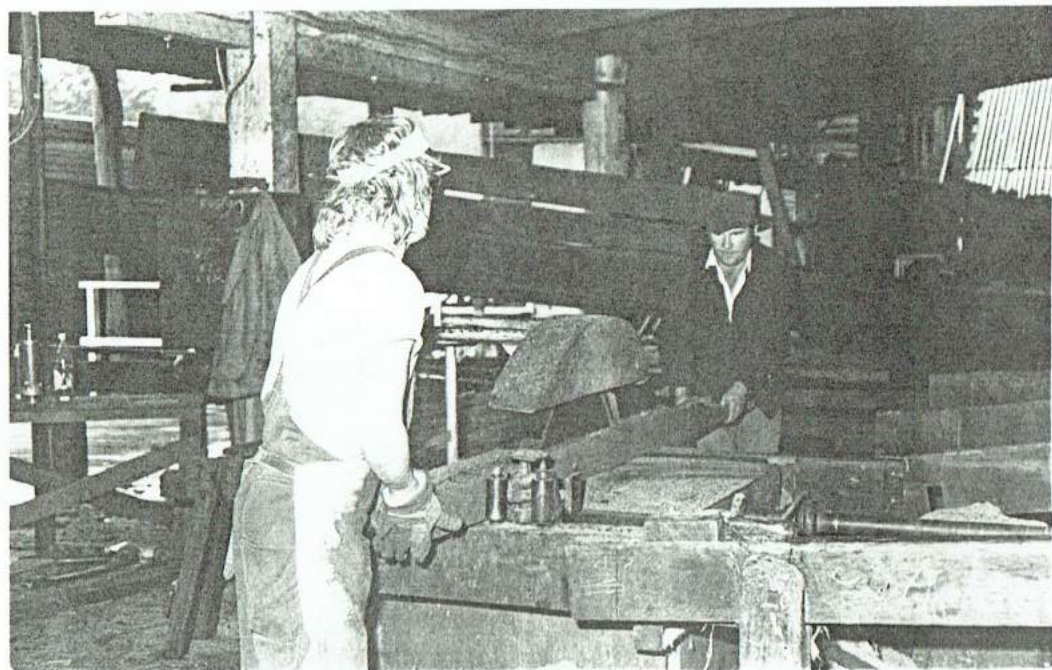
A feature of the mill was the reduction of timber waste and the production of timber fruit cases assisted this function. A special production area consisting of 3 saw benches was incorporated into the mill for this purpose. This equipment remains.

26. Fruit Case Saw Area. *operating mill 1978*

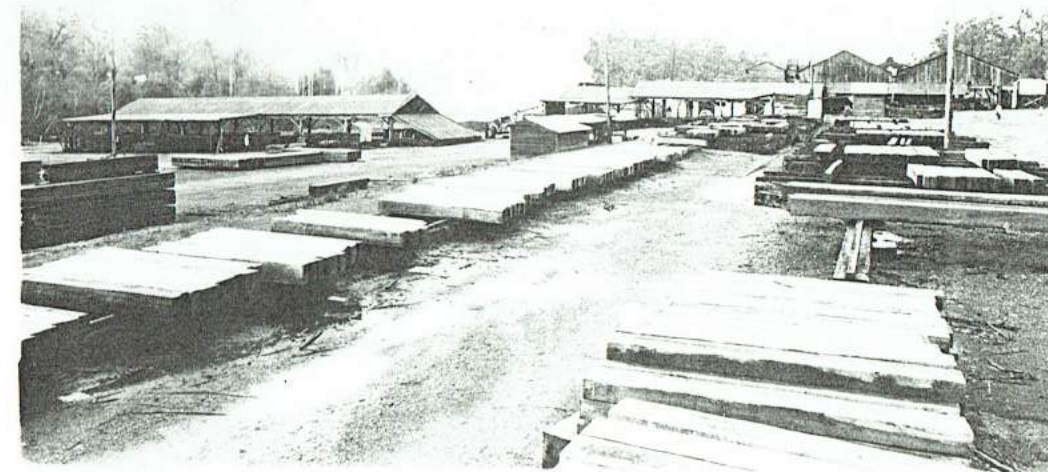
This area remains although the rails used to transfer timber to the area have been removed. (Photo 27)

27. Mill Yard Area. *OPERATION MILL 1978*

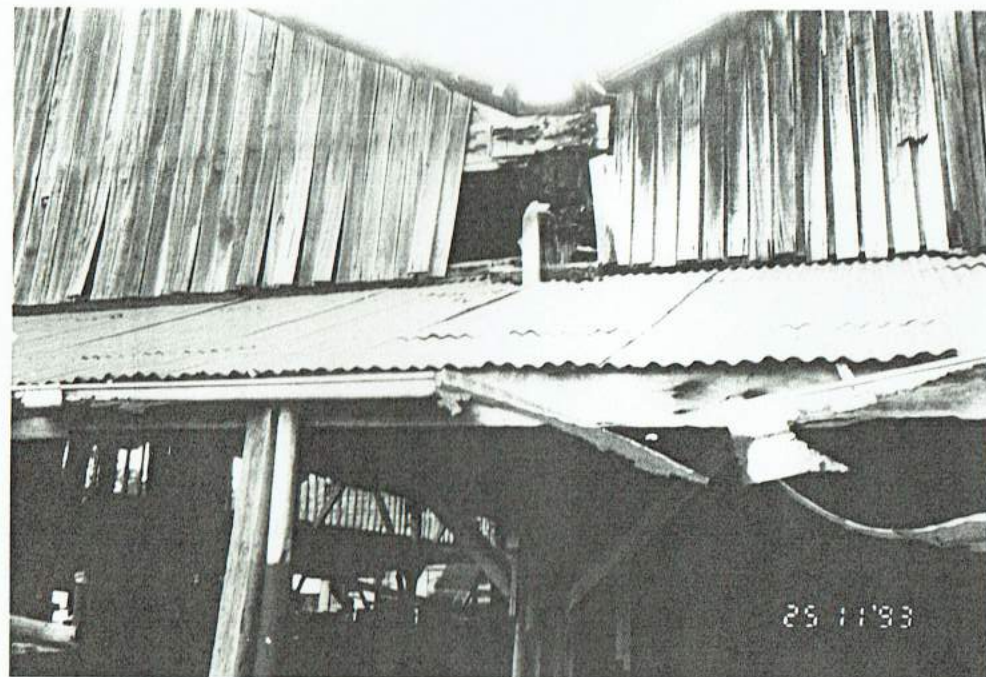
32. Timber Deterioration On Central Column At West End Of Main Mill Building. 1993

The only area of obvious deterioration is the central column and corbel top at the west end of the building where the roof box gutter has deteriorated and the roof water is discharging directly onto the timber column. (Photo 32)

Fungicide treatment to the floor & roof columns should be carried out at ground level.

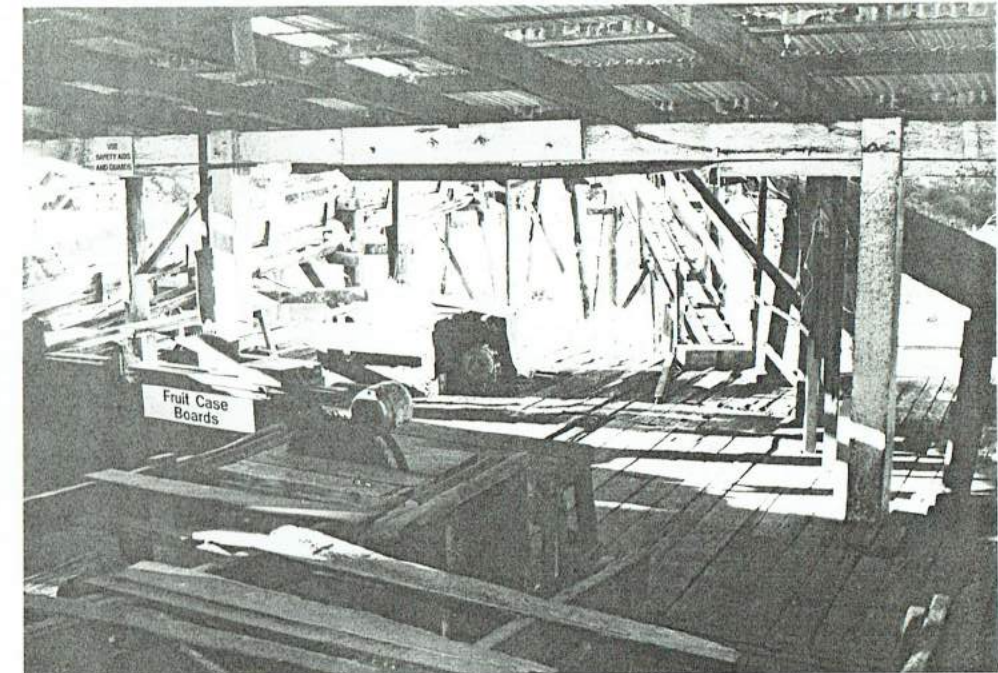
EXISTING
33. Fruit Packing Case Area. 1994

In this section the roof rain runoff is discharging onto the flooring which has severely deteriorated.

The roof needs maintenance and the flooring is unsafe and requires reconstruction.

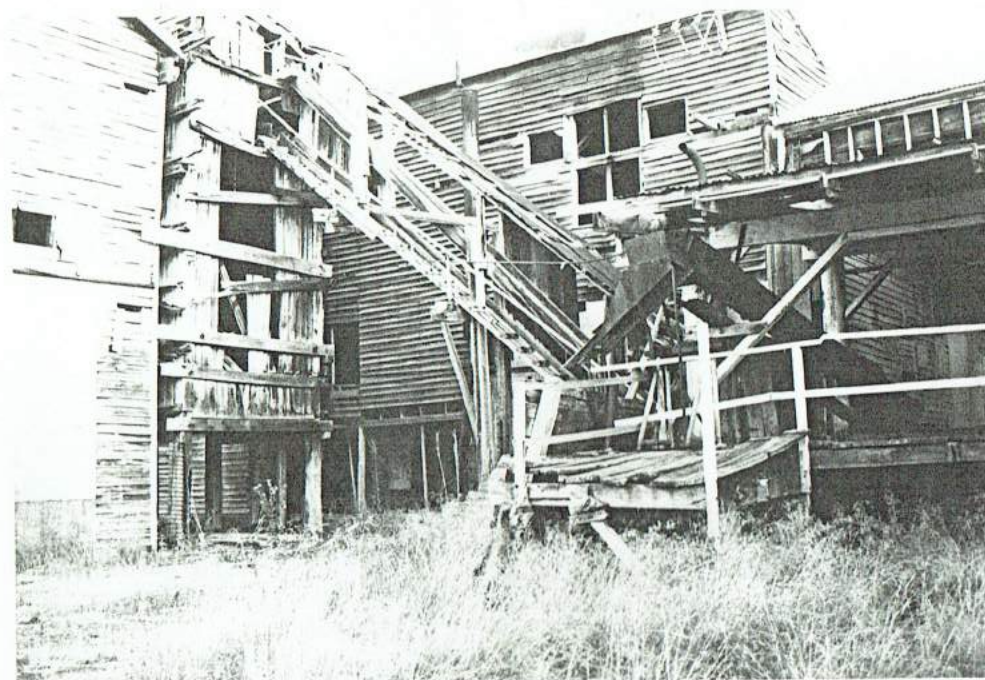
EXISTING
35. Sawdust Hopper And Supply Conveyor. 1994

This hopper has deteriorated but illustrates the key component of the mill in utilising sawdust collected on conveyors under the mill floor for collection into the sawdust hopper for feeding to the boiler as a fuel.

The building needs to be assessed in regard to its potential for restoration. (Photo 35)

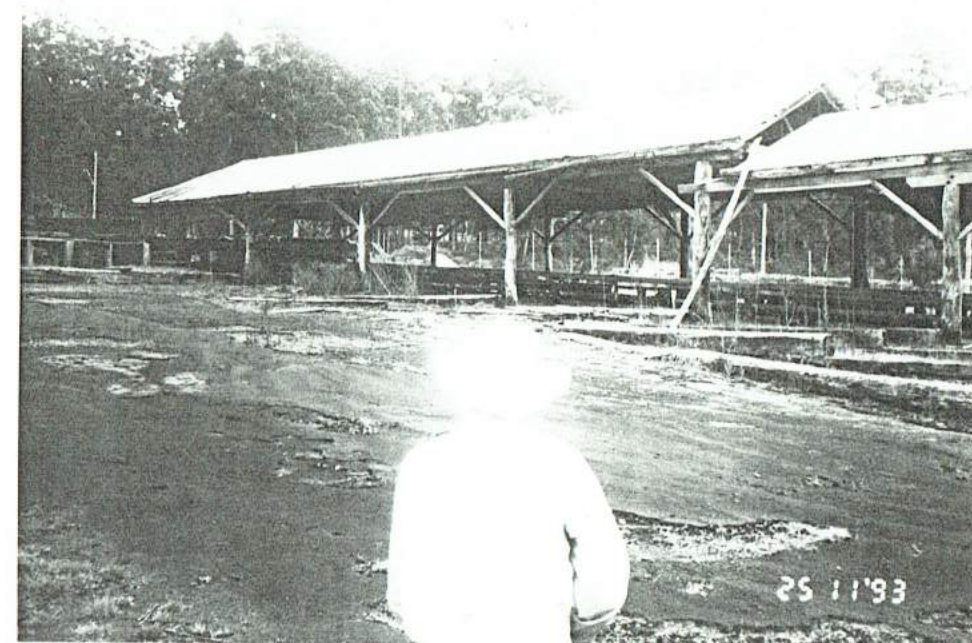
EXISTING
36. Sorting Shed Roof Structure. 1993

This structure is entirely of timber construction and protects the moving cable equipment installed on the sorting table. (Photo 36)

This structure is in reasonable condition however the roofing iron needs to be assessed to achieve preservation.

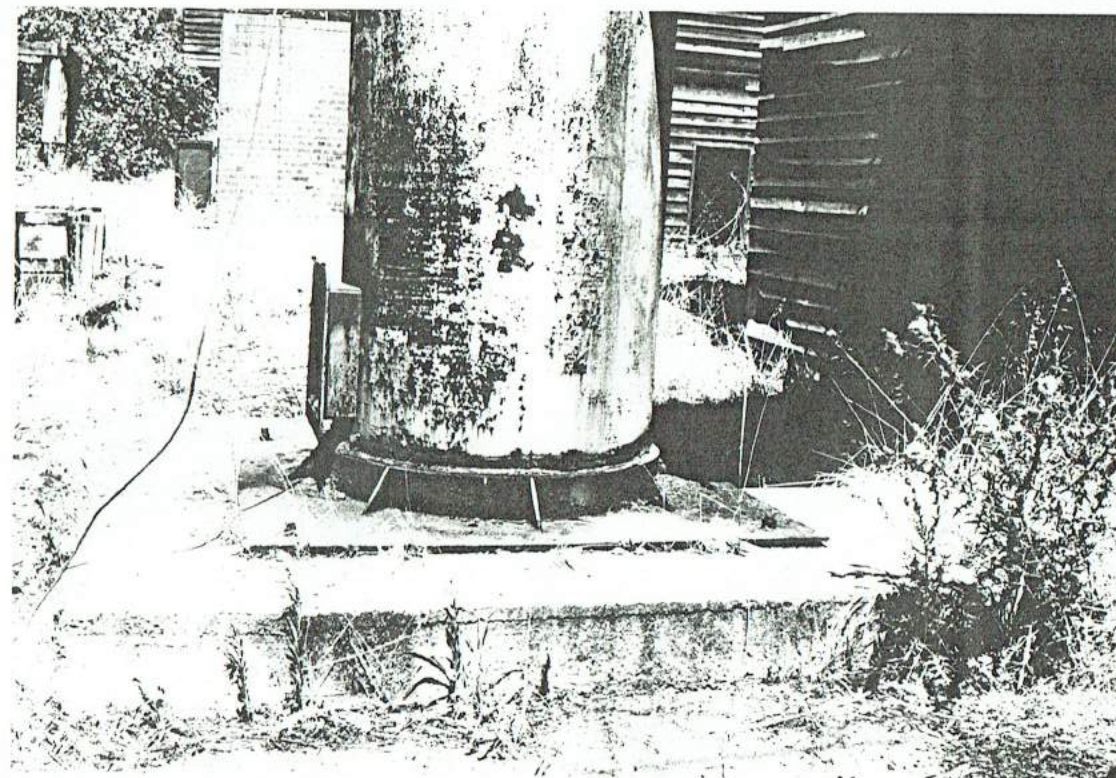
38. Base Of One Of The Chimneys.

The structural adequacy of the chimneys need to be further assessed. There is evidence of corrosion on the inside of the chimneys at the bottom 1 metre height from the base and it will be necessary to weld further plate on the outside to reinforce this section together with a strengthening of the steel flange at foundation level. (Photo 38)

The chimneys need to be checked and painted and this can be carried out by experienced steeple jacks who are available.

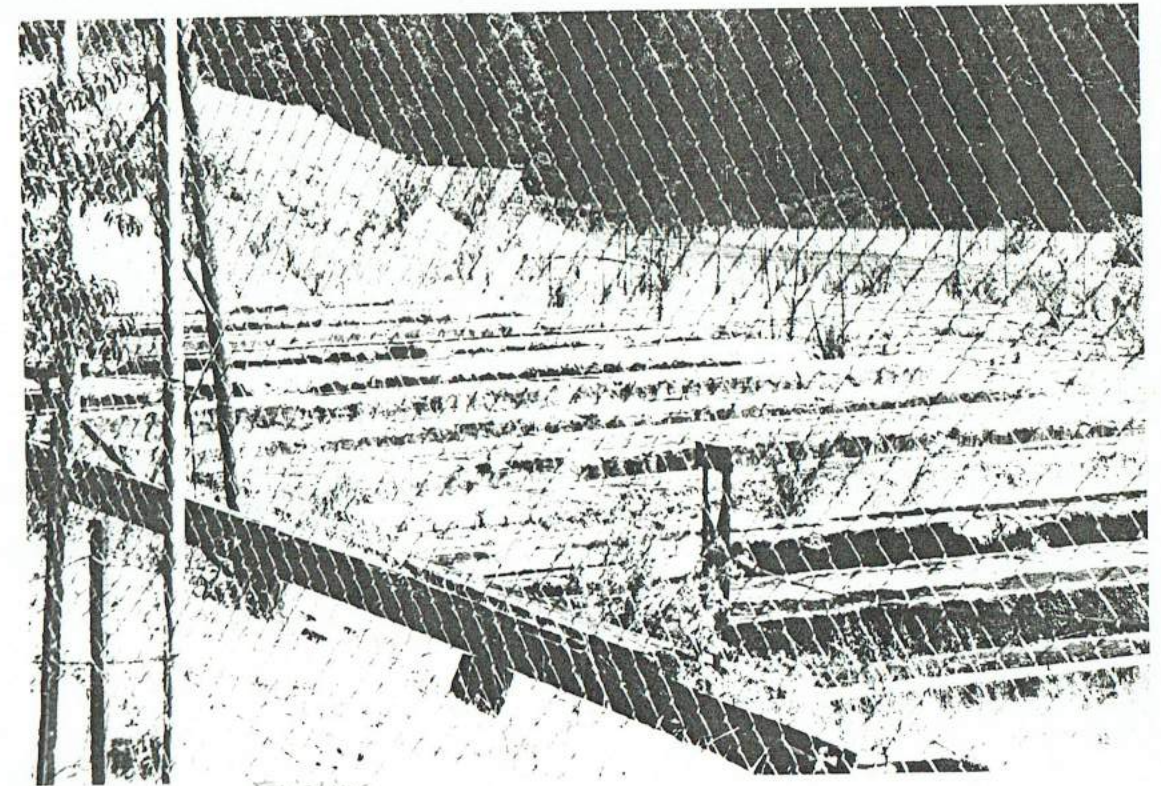
41. Existing Photo Of Kiln Foundation. 1994

The Babcock and Wilcox boiler supplying steam to the kilns remains and also the concrete foundations of the kilns. (Photo 41)

In presenting the conserved mill the kiln foundations occupy a relatively small area, and it is proposed that these should remain to provide as complete as possible interpretation. This area should be included in the future mill site.

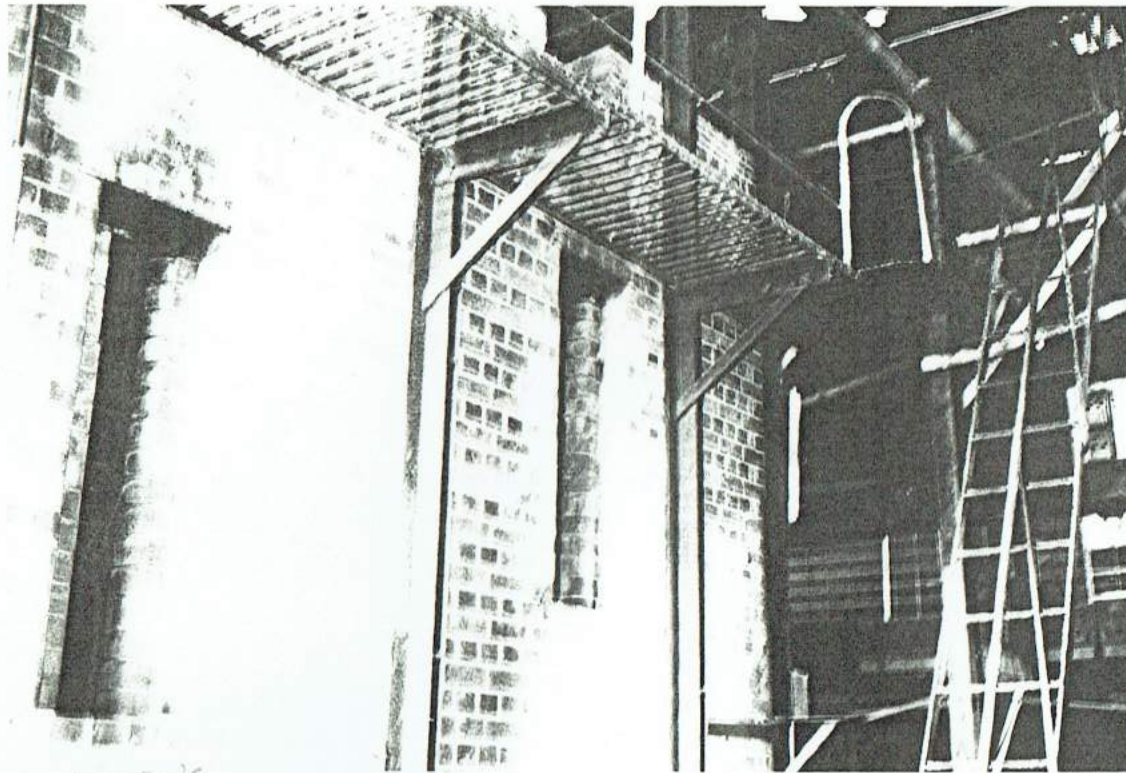
EXISTING
44. Steam Boiler, Brickwork, Access Landings. 1994

Although there is evidence of corrosion and the boilers would need extensive reconstruction to meet the safety requirements for refiring and steam production, this is not recommended.

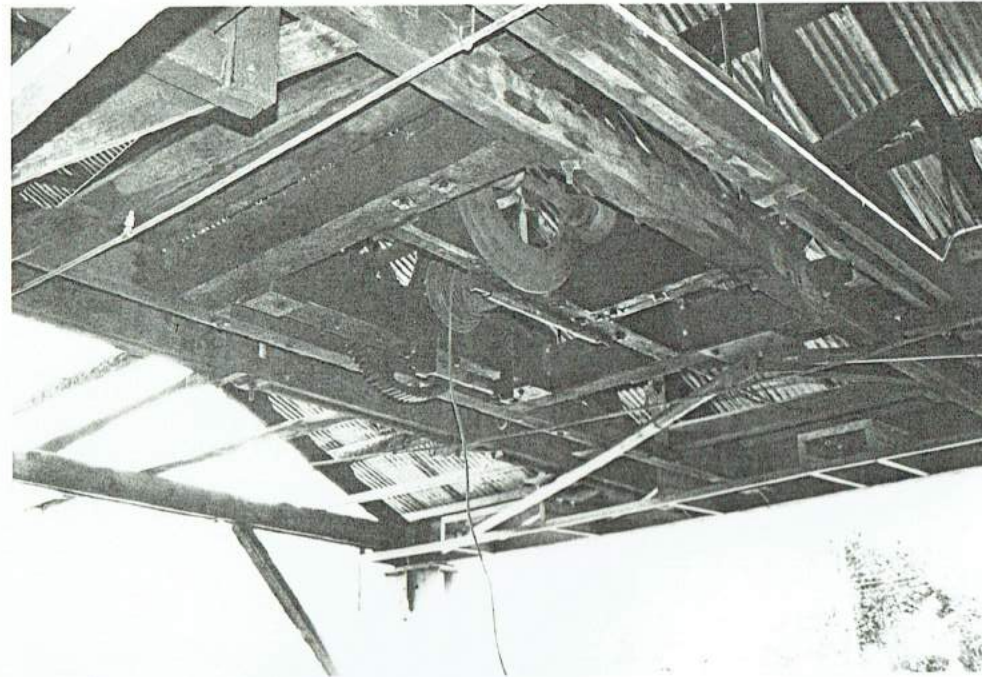
EXISTING
45. Overhead Log Handling Winch. 1994

(Photo 45)
This overhead winch is belt driven from the main drive and should be preserved to illustrate the technology and method of log handling on the storage skids for entry into the mill. *The winch was used to remove logs from the log trolley onto the storage skids and then load these logs onto the traveller carriage.*

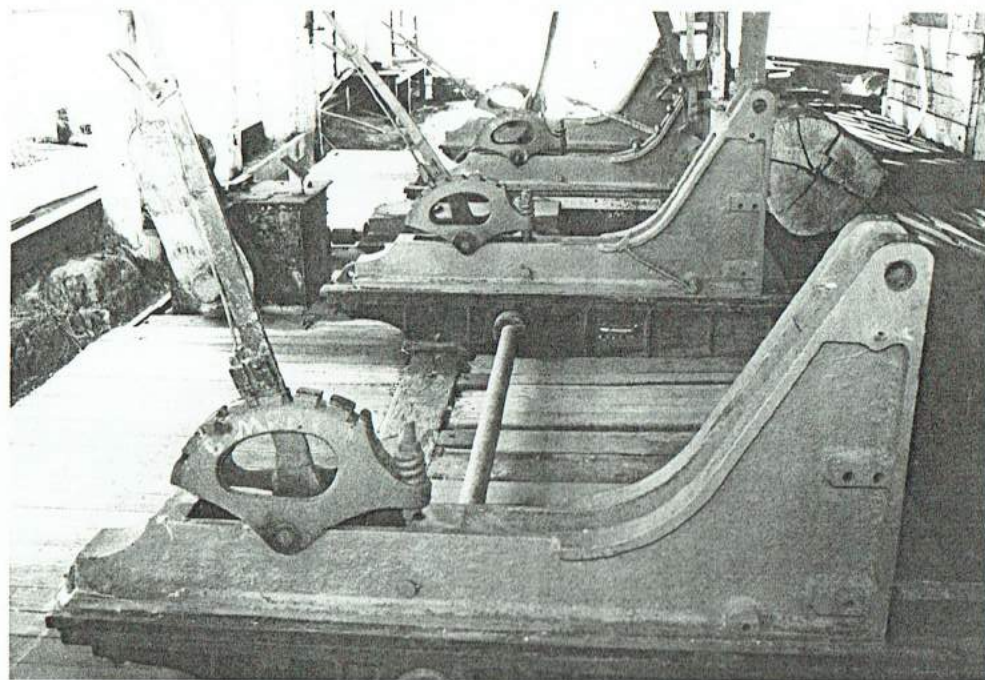
47. Existing Log Carriage. 1994

The log carriage remains in an almost complete condition as shown in Photo 47 below and also photo 20.

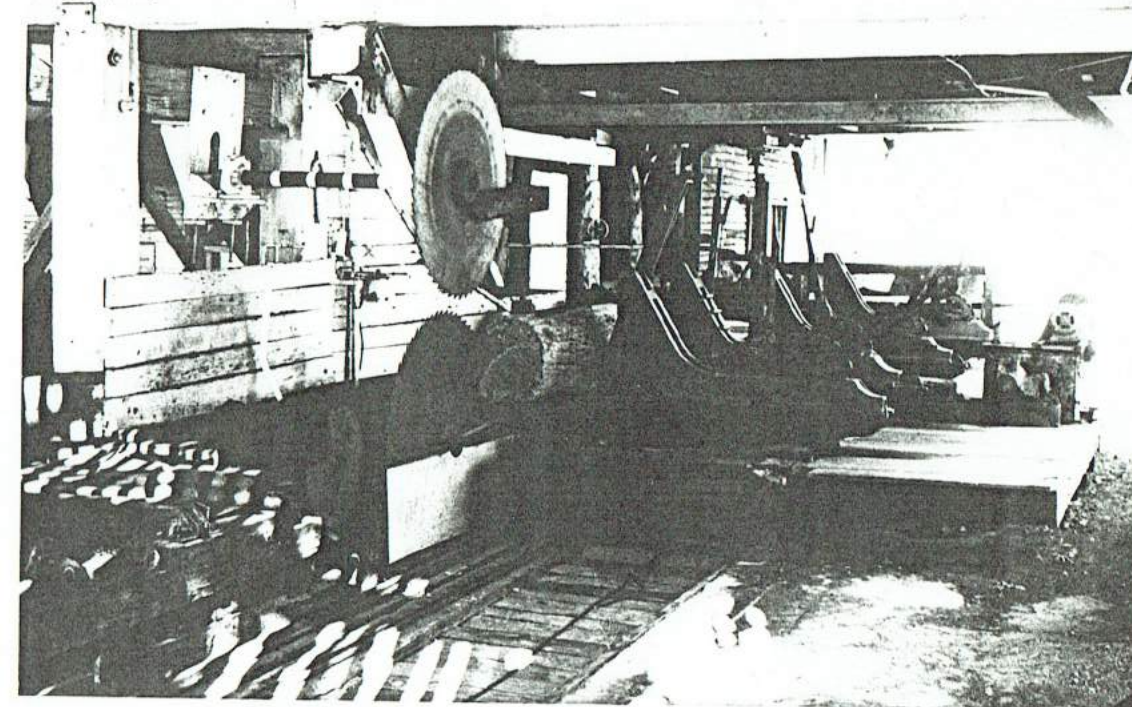
48. Existing Twin Saws. 1994

These saws remain in position together with the drive shafts and should be preserved.

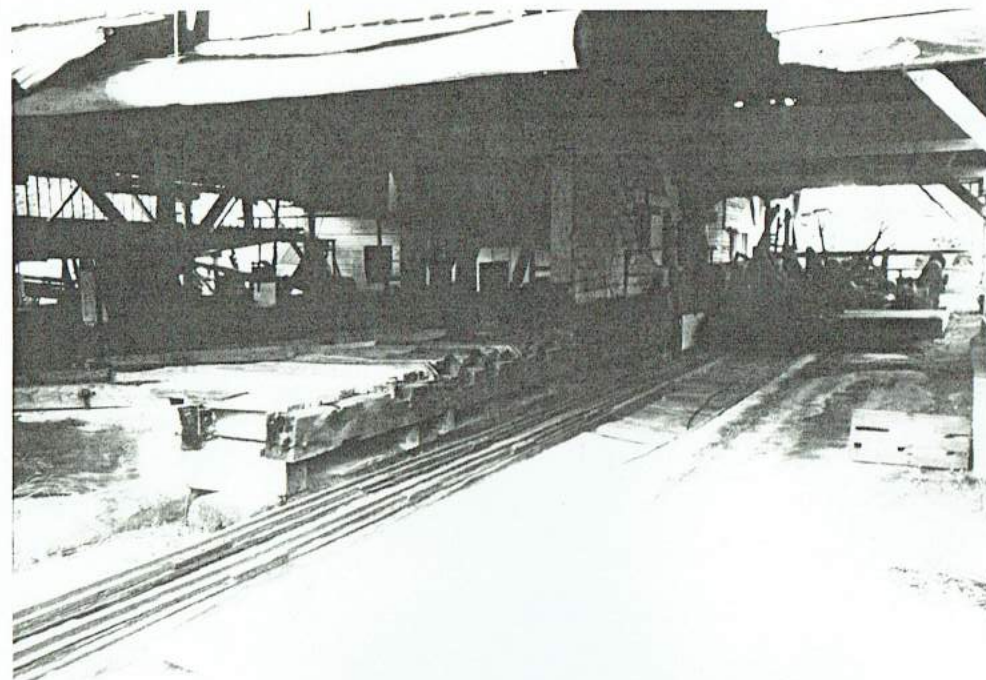
EXISTING
49. Twin Saw Skids & Power Rollers. 1994

All this system remains in reasonable condition including the under floor drive system and is recommended for preservation.
